THE ANALYSIS OF CAUSES OF LORRY PISTON COMBUSTION ENGINE DAMAGE

ABSTRACT

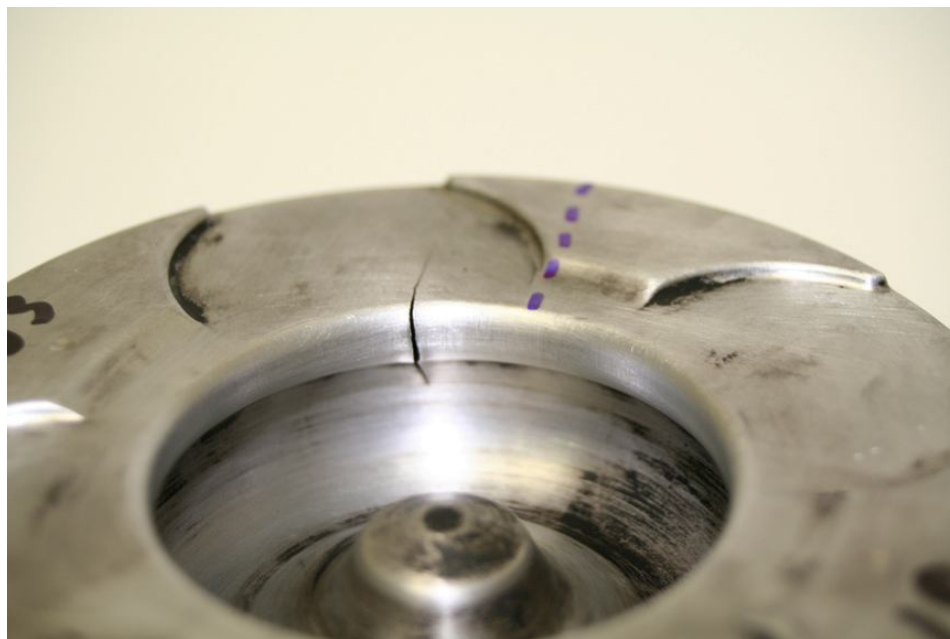
Fig:-2 Place of burnout sideways of piston and crack propagation

Two base options of piston degradation (except abrasion) were known by visual investigation of harm piston combustion engine. initially the crack was created that rose up to the opening into piston pivot (Fig. 2) and stopped virtually at the center active piston half. The second feature was comparatively huge burnout holes in active and conjointly sideways a part of the gear piston. The ring was joined with piston in burnout place, distinctively abrasively worn and broken. as a attributable to the burnout localization near the crack it can't be expressed that burnout was instigator of piston harm however burnout was result of crack formation and its propagation in exhibition method of piston. in this case attention was targeted on crack that had an equivalent form in each broken combustion engine pistons. External cylindrical surface was worked on the bottom of morphology by roughly latheturning. Probably, cutting implement caused tearing out of fabric by wrong machining parameters in hole place for piston (Fig. 3) from
